MAY 1957

approach

NAVAER 00-75-510

THE NAVAL AVIATION SAFETY REVIEW

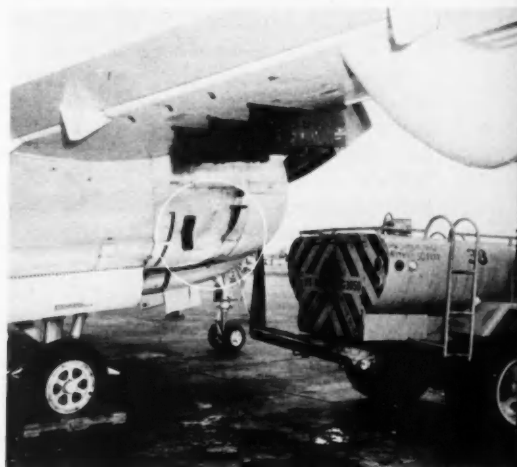
The driver backed to within 4 feet of the S2F and upon departing, inadvertently shifted into reverse. Dents and gashes in cowl are circled.

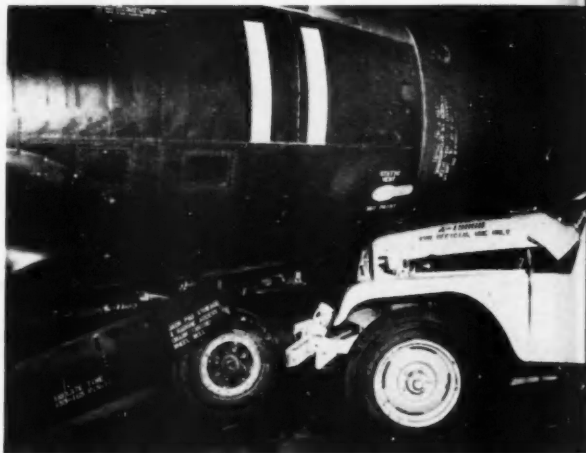
F3D nightfighter offered no contrast to night background for the driver of "FOLLOW ME" jeep.
